**Flood Control Project Maintenance
Levee Inspections****LMA District Cover Sheet
Spring 2014 Levee Inspection Results****Sutter Maintenance Yard Maintenance Area 0001**

Spring 2014 Levee Inspection Results

Sutter Maintenance Yard Maintenance Area 0001

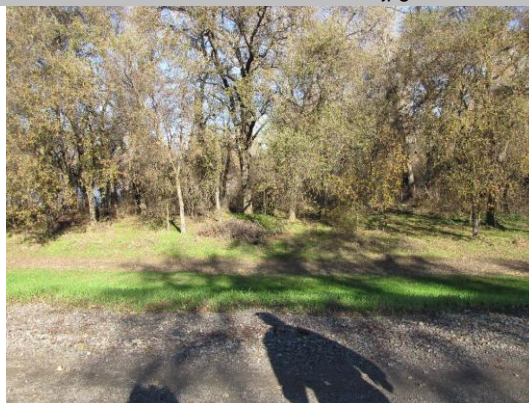
Photo 1 of 1 : UCIP_4876.jpg

View of waterward side--no features present.

LM Start	3.96	Rating **	M	Issue No.	50
LM End	3.96	Issue Type +	Ma	Location *	LS
Category	Earthen Levee			GPS Latitude/Longitude	
				Start	End
Item	Vegetation			39.257125 °	39.257125 °
				-122.012648 °	-122.012648 °

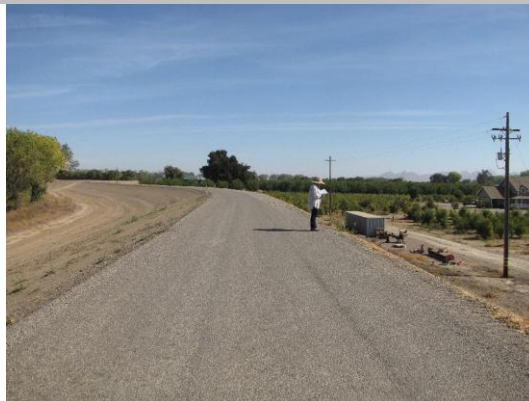
Photo 1 of 1 : UCIP_4893.jpg

View of levee crown looking downstream at crossing.

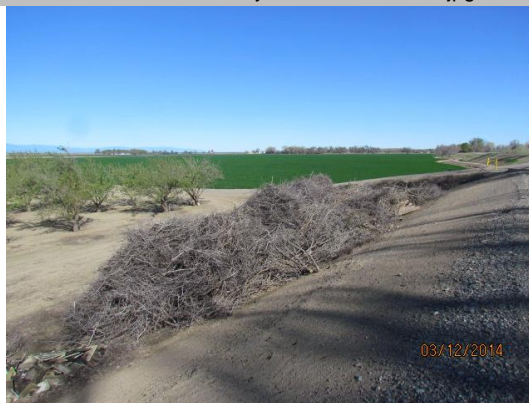
Photo 1 of 1 : rduffey_s_20140317_122.jpg

LM Start	6.51	Rating **	M	Issue No.	77
LM End	6.51	Issue Type +	En	Location *	LS
Category	Earthen Levee			GPS Latitude/Longitude	
				Start	End
Item	Encroachments			39.281364 °	39.281364 °
				-122.022038 °	-122.022038 °
DWR ID	DWR_MA0001_01_s _ 2014_77				
Action/Comments					
Prunings

View of the prunings along the landside toe.

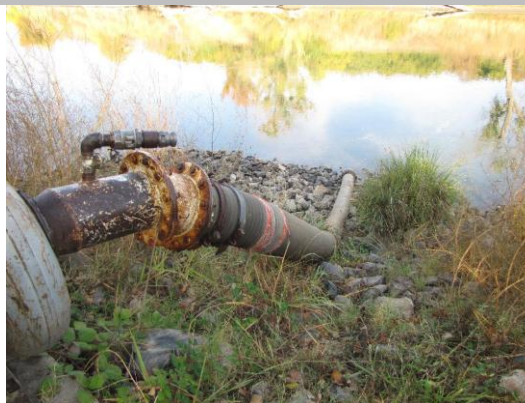
Photo 1 of 2 : UCIP_4939.jpg

LM Start	7.74	Rating **	M	Issue No.	53
LM End	7.74	Issue Type +	En	Location *	LS
Category	Supplemental			GPS Latitude/Longitude	
				Start	End
Item	DWR UCIP Field Study			39.297384 °	39.297384 °
				-122.022989 °	-122.022989 °
DWR ID	DWR_MA0001_01_s_2014_53				
Action/Comments					
Inspector Comments: FS_ID:25797					
EP_NO: 12334					
Repair Type:					
Crossing Status:					
UCIP Comments: Siphon breaker housing unit is bent and has debris inside. LS outlet not found 7/18/2013 Same as last inspection 12/17/2013 Same as last inspection.					
FIELD_STRUCT_DESC: 10-inch steel pipe through levee, 3 feet below the crown. Centrifugal pump on the bank. Siphon breaker on landward shoulder of the levee. (Permit No. 12334-1978, James Jean)					
FS Date: 12/30/2013 1:02:18 PM

Pump located on waterward bank.

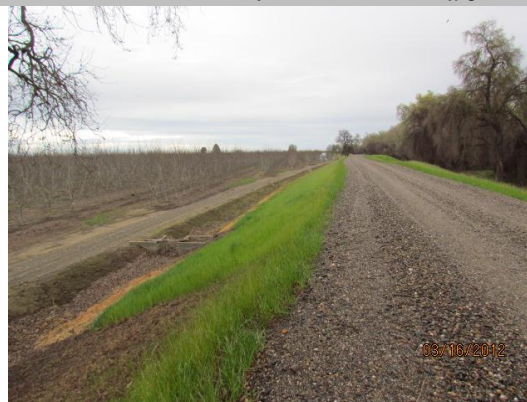
Photo 1 of 1 : rduffey_s_20140304_325.jpg

LM Start	8.94	Rating **	M	Issue No.	25
LM End	9.39	Issue Type +	En	Location *	LS
Category	Earthen Levee			GPS Latitude/Longitude	
				Start	End
Item	Encroachments			39.308390 °	39.315125 °
				-122.031157 °	-122.030206 °
DWR ID	DWR_MA0001_01_s _ 2012_25				
Action/Comments					
Ditch

View of the ag. ditch along the L/S toe.

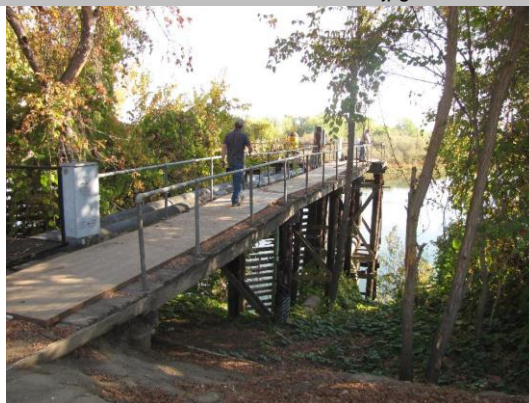
Photo 1 of 1 : UCIP_4951.jpg

LM Start	10.43	Rating **	M	Issue No.	57
LM End	10.43	Issue Type +	En	Location *	WS
Category	Supplemental			GPS Latitude/Longitude	
				Start	End
Item	DWR UCIP Field Study			39.329749 °	39.329749 °
				-122.029602 °	-122.029602 °
DWR ID	DWR_MA0001_01_s_2014_57				
Action/Comments					
Inspector Comments: FS_ID:25800					
EP_NO: N/A					
Repair Type:					
Crossing Status:					
UCIP Comments: Landward side has been completely altered. Need to find permit for new work/18/2013 Same as last inspection12/17/2013 Same as last inspection.					
FIELD_STRUCT_DESC: 24-inch steel pipe through levee. Gate valve on the waterward end. (USACE, 1955) This entry matches the Drainage and Irrigation Structure referenced in O&M manual (538+42).					
FS Date: 12/30/2013 1:05:22 PM

Dual 14-inch pipes along catwalk. 24-inch pipe crosses approximately 8 feet below catwalk floor.

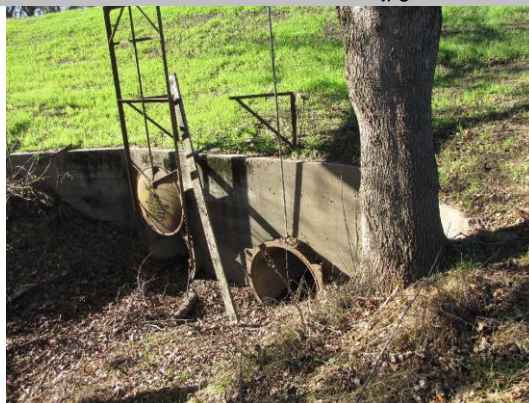
Photo 1 of 1 : UCIP_4979.jpg

LM Start	11.25	Rating **	M	Issue No.	60
LM End	11.25	Issue Type +	En	Location *	LS
Category	Supplemental			GPS Latitude/Longitude	
				Start	End
Item	DWR UCIP Field Study			39.340867 °	39.340867 °
				-122.032932 °	-122.032932 °
DWR ID	DWR_MA0001_01_s_2014_60				
Action/Comments					
Inspector Comments: FS_ID:25808					
EP_NO: 187					
Repair Type:					
Crossing Status:					
UCIP Comments: Need to determine if structure is still in use--contact owner. If abandoned structure--structure needs to be properly abandoned. This crossing was listed in the USACE Periodic Inspections as ID# USACE_CESPK_MA1C_2010_p_0393 missing gate/18/2013 Same as last inspection12/17/2013 Same as last inspection.					
FIELD_STRUCT_DESC: 1 of 2: 52-inch CMP through levee. Slide gate on waterward side and flap gate on landward side. Concrete headwalls at both sides. This structure is associated with another abandoned structure located on waterward side. Abandoned structure includes pump house, multiple concrete walls, and 3 additional crossings (2-30 inch pipes and 1-48 inch pipe). (Permit No. 187-1921, Compton-Delevan Irrigation District-Maxwell I.D.)

Slide gates for 52-inch pipes through levee (higher levee).

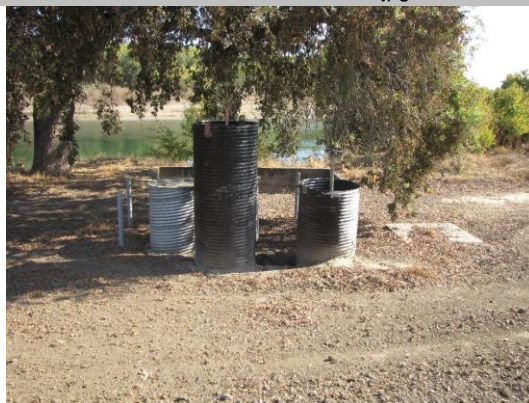
Photo 1 of 1 : UCIP_4989.jpg

Action/Comments					
Inspector Comments: FS_ID:25811					
EP_NO: 17471					
Repair Type:					
Crossing Status:					
UCIP Comments: Erosion between risers with slide gates located on waterward side; This crossing was listed in the USACE Periodic Inspections as ID# USACE_CESPK_MA1C_2010_p_0398 for possible sinkhole between access gate structure 7/18/2013 Same as last inspection 12/17/2013 Same as last inspection.					
FIELD_STRUCT_DESC: 1 of 2: 18 inch diameter HDPE discharge pipes to be connected to the existing standpipe risers within the waterside and parallel to the right (west) bank levee of Sacramento River. Pump station is located approximately 450 feet upstream of crossing. (Permit 17471-2002, Maxwell Irrigation District)					
FS Date: 12/30/2013 1:48:40 PM

View of CMP risers located on waterward side.

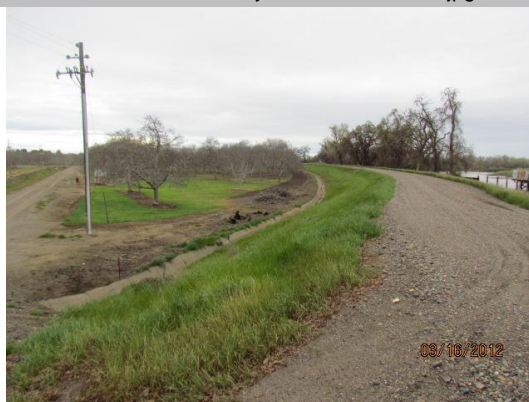
Photo 1 of 1 : rduffey_s_20140304_326.jpg

LM Start	11.45	Rating **	M	Issue No.	27
LM End	11.71	Issue Type +	En	Location *	LS
Category	Earthen Levee			GPS Latitude/Longitude	
				Start	End
Item	Encroachments			39.343542 °	39.347185 °
				-122.032107 °	-122.031525 °
DWR ID	DWR_MA0001_01_s_2012_27				
Action/Comments					
Ditch

View of the ag. ditch along the L/S toe.

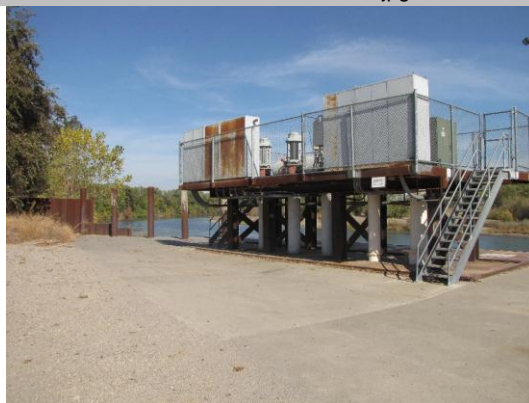
Photo 1 of 1 : UCIP_5004.jpg

LM Start	11.51	Rating **	M	Issue No.	64
LM End	11.51	Issue Type +	En	Location *	LS
Category	Supplemental			GPS Latitude/Longitude	
				Start	End
Item	DWR UCIP Field Study			39.344376 °	39.344376 °
				-122.031792 °	-122.031792 °
DWR ID	DWR_MA0001_01_s_2014_64				
Action/Comments					
Inspector Comments: FS_ID:25817					
EP_NO: N/A					
Repair Type:					
Crossing Status:					
UCIP Comments: Need to determine encroachment permit associated with this crossing 7/22/2013 Same as last inspection 12/17/2013					
Same as last inspection.					
FIELD_STRUCT_DESC: 1 of 3: 24 inch discharge pipe through levee.					
Crossing is tied to existing Maxwell Irrigation District Pump Station located on waterward side. Siphon breaker inside CMP riser located on landward shoulder.					
FS Date: 12/30/2013 1:57:23 PM

Pump station located on waterward side.

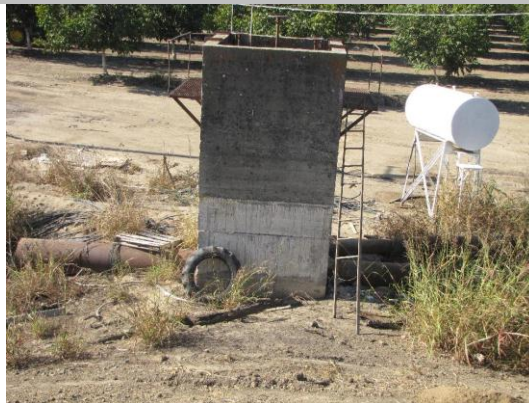
Photo 1 of 1 : UCIP_5019.jpg

Concrete distribution box located on landward toe.

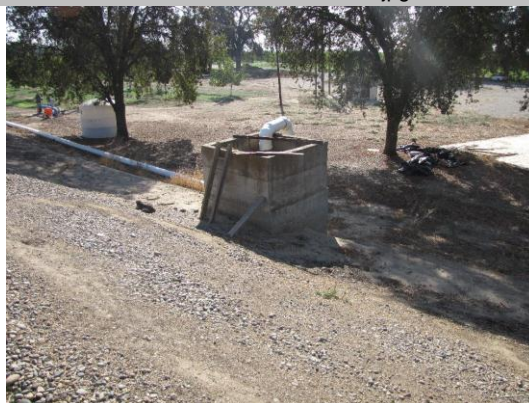
Photo 1 of 1 : UCIP_5026.jpg

Concrete distribution box located on landward toe.

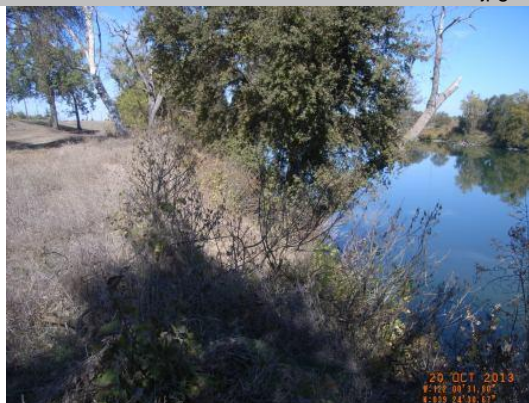
Photo 1 of 2 : USACE2013A_SAC_164-3_R_1.jpg

LM Start	16.34	Rating **	M	Issue No.	1
LM End	16.57	Issue Type +	Ma	Location *	WS
Category	Supplemental			GPS Latitude/Longitude	
				Start	End
Item	USACE Erosion Survey			39.411111 °	39.407837 °
				-122.009238 °	-122.008763 °
DWR ID					
Action/Comments					
Inspector Comments: Erosion site added in 1997 and removed in 2005. 2009 - Site added back in, hard toe with slow moving erosion. Potential geotechnical failure. 2011 - Site extended downstream. 2013: No observed changes. [2013 Site ID: SAC_164-3_R]

USACE 2013 Photo #1

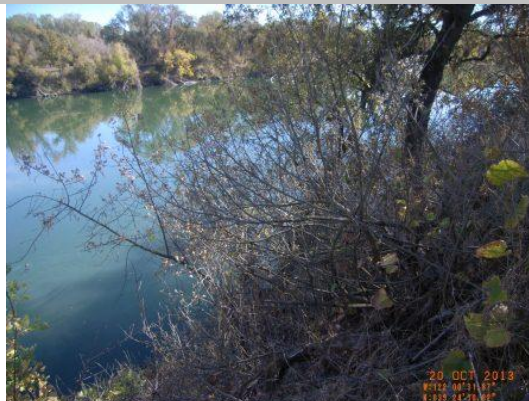
Photo 2 of 2 : USACE2013A_SAC_164-3_R_3.jpg

LM Start	16.34	Rating **	M	Issue No.	1 (cont)
LM End	16.57	Issue Type +	Ma	Location *	WS
Category	Supplemental			GPS Latitude/Longitude	
				Start	End
Item	USACE Erosion Survey			39.411111 °	39.407837 °
				-122.009238 °	-122.008763 °
DWR ID					
Action/Comments					
Inspector Comments: Erosion site added in 1997 and removed in 2005. 2009 - Site added back in, hard toe with slow moving erosion. Potential geotechnical failure. 2011 - Site extended downstream. 2013: No observed changes. [2013 Site ID: SAC_164-3_R]

USACE 2013 Photo #2
